## Silicon Precipitate Nodule-Induced Failures of MOSFETs

M. Johnson and D. Pote  
Motorola, Inc.  
Northbrook, IL

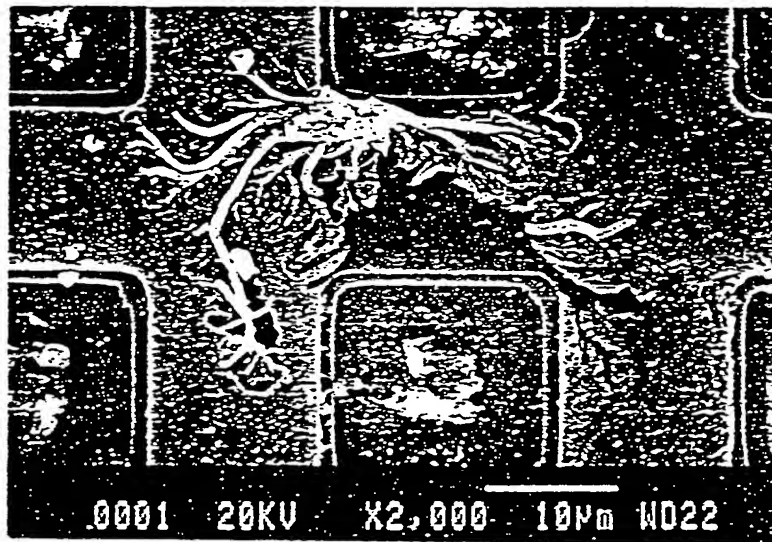
Figure 1: Unique pattern of fused polysilicon observed after removal of metallization and insulating oxide. (2000X)

Subsequent optical inspection identified an apparent electrical damage site under the wirebond. This damage was characterized by a central fused-site surrounded by multiple filaments (Figure 1). These filaments were dubbed "tentacles" or "roadkill" damage because of their appearance. SEM inspection of the same locations revealed surprisingly little

It is now believed that the filaments are the result of amplification of the damage at the original failure sites by the application of excess power during liquid crystal testing. A slightly higher level of power was necessary to counteract the obstructing heatsink effect of the relatively large wirebond. The heat generated at the damage site would initiate crystallization of the amorphous polysilicon depend-

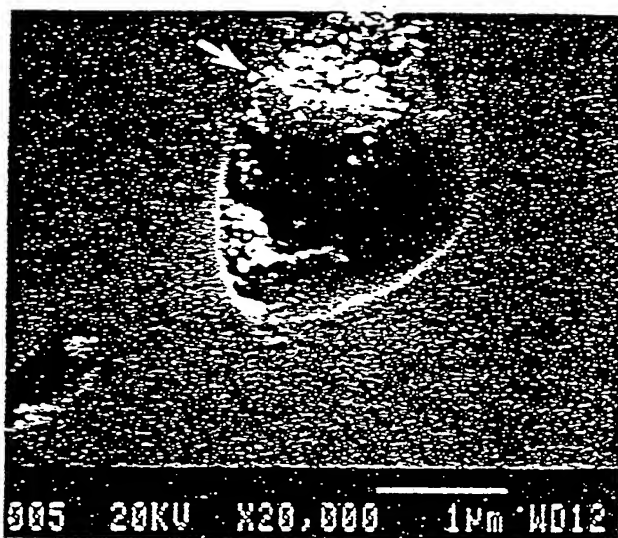
Figure 2: Small electrical damage site within chip.  
(25000X)

Cross-sections of failures revealed that the filaments were confined to the polysilicon layer, except at the central nucleus. At the nucleus, melted silicon and aluminum were observed extending vertically through the dielectric layer. On several devices where the filamentation was minimal, there was limited evidence of melting at the nucleus site and a small section or chip of the dielectric was missing (figure 2).

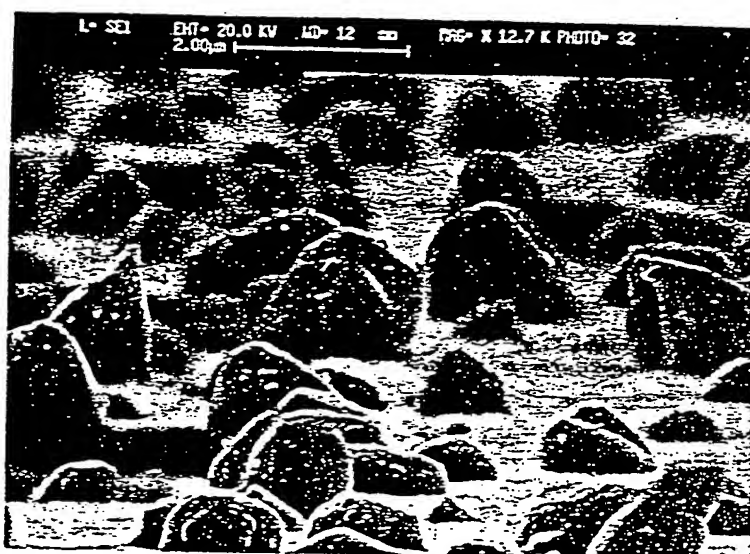
shape. Although they appear roughly circular under high power microscopy (400X), they are actually polyhedral and exhibit a wide range of aspect ratios (Figure 3). Typical height/width ratios range from 0.3 to 1.8.

Figure 3: Silicon precipitates (nodules) viewed from side exhibit variety of shapes and sizes. (12700X)

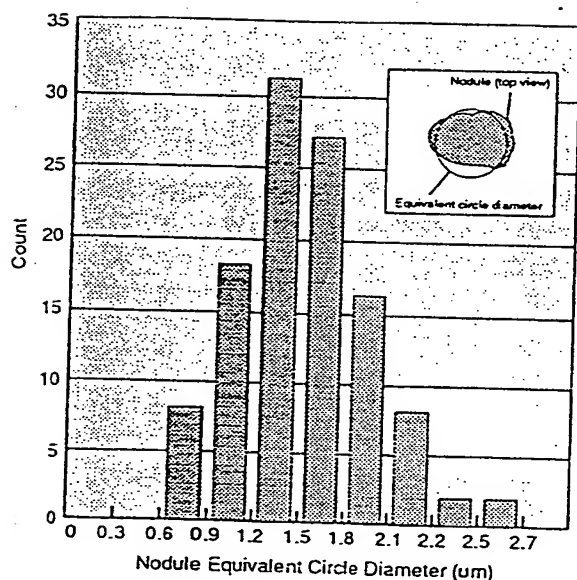
There were typically  $50 \times 10^3$  to  $100 \times 10^3$  nodules per square millimeter in the subject devices. In general, the nodule density -- the number of nodules per unit surface area -- was inversely proportionate to the average size of the nodules. That is, when the nodules were large, there tended to be few of them. Conversely, when the nodule count was high, they tended to be small. Figure 4 shows a typical histogram of nodule sizes produced by an image analysis

Figure 4: Example distribution of nodule sizes

system capable of performing feature counting. Unfortunately, easily measured characteristics of the nodules, such as density (count/area), could not be easily correlated to failure rate. It is hypothesized that the probability of failure is governed by extreme value statistics (weakest link theory), and detailed info regarding the shape and size of the nodules can be difficult to obtain on a large number of samples.

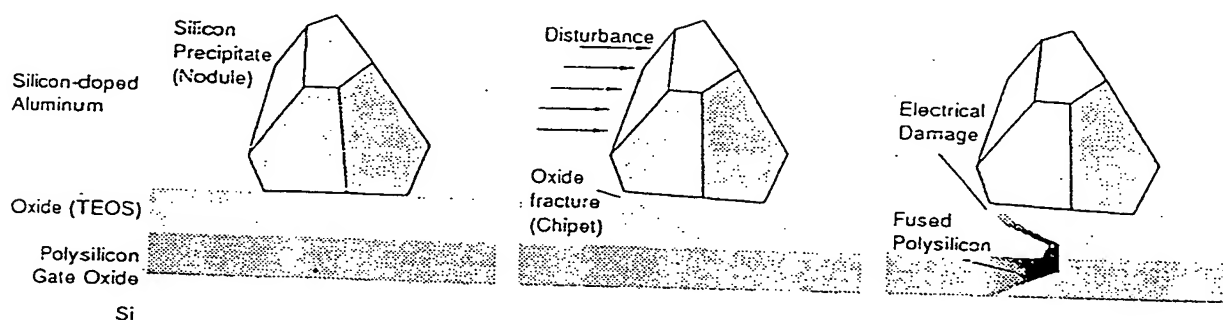
The adhered nodules could be removed quite easily; gentle brushing of a few fibers from a cotton swab was sufficient to disturb them. When these well-adhered nodules are displaced, they often take with them a portion of underlying oxide, forming a distinctive, football-shaped chip-out, or *chipet* (Figure 5). The depth of the resulting chipet was roughly equal to half the length of the chipet's minor axis, itself related to the area of contact between nodule and oxide.

In the MOSFET devices the lateral displacement of the nodules occurs during the wirebonding process. The cavity formed by the chipet is immediately filled with aluminum. These chipets, during

Figure 5: Movement of nodule results in fracture of underlying oxide.

electrical stress, appear to act as weak points in the insulating oxide. If the chiplet is sufficiently deep to fully compromise the thickness of the dielectric oxide, a linear resistive short between the source metallization and gate polysilicon results. However, if the root only partially compromises the dielectric, a leaky diode-like characteristic results.
